# Upper Witham Restoration

David Hutchinson – Environment Agency

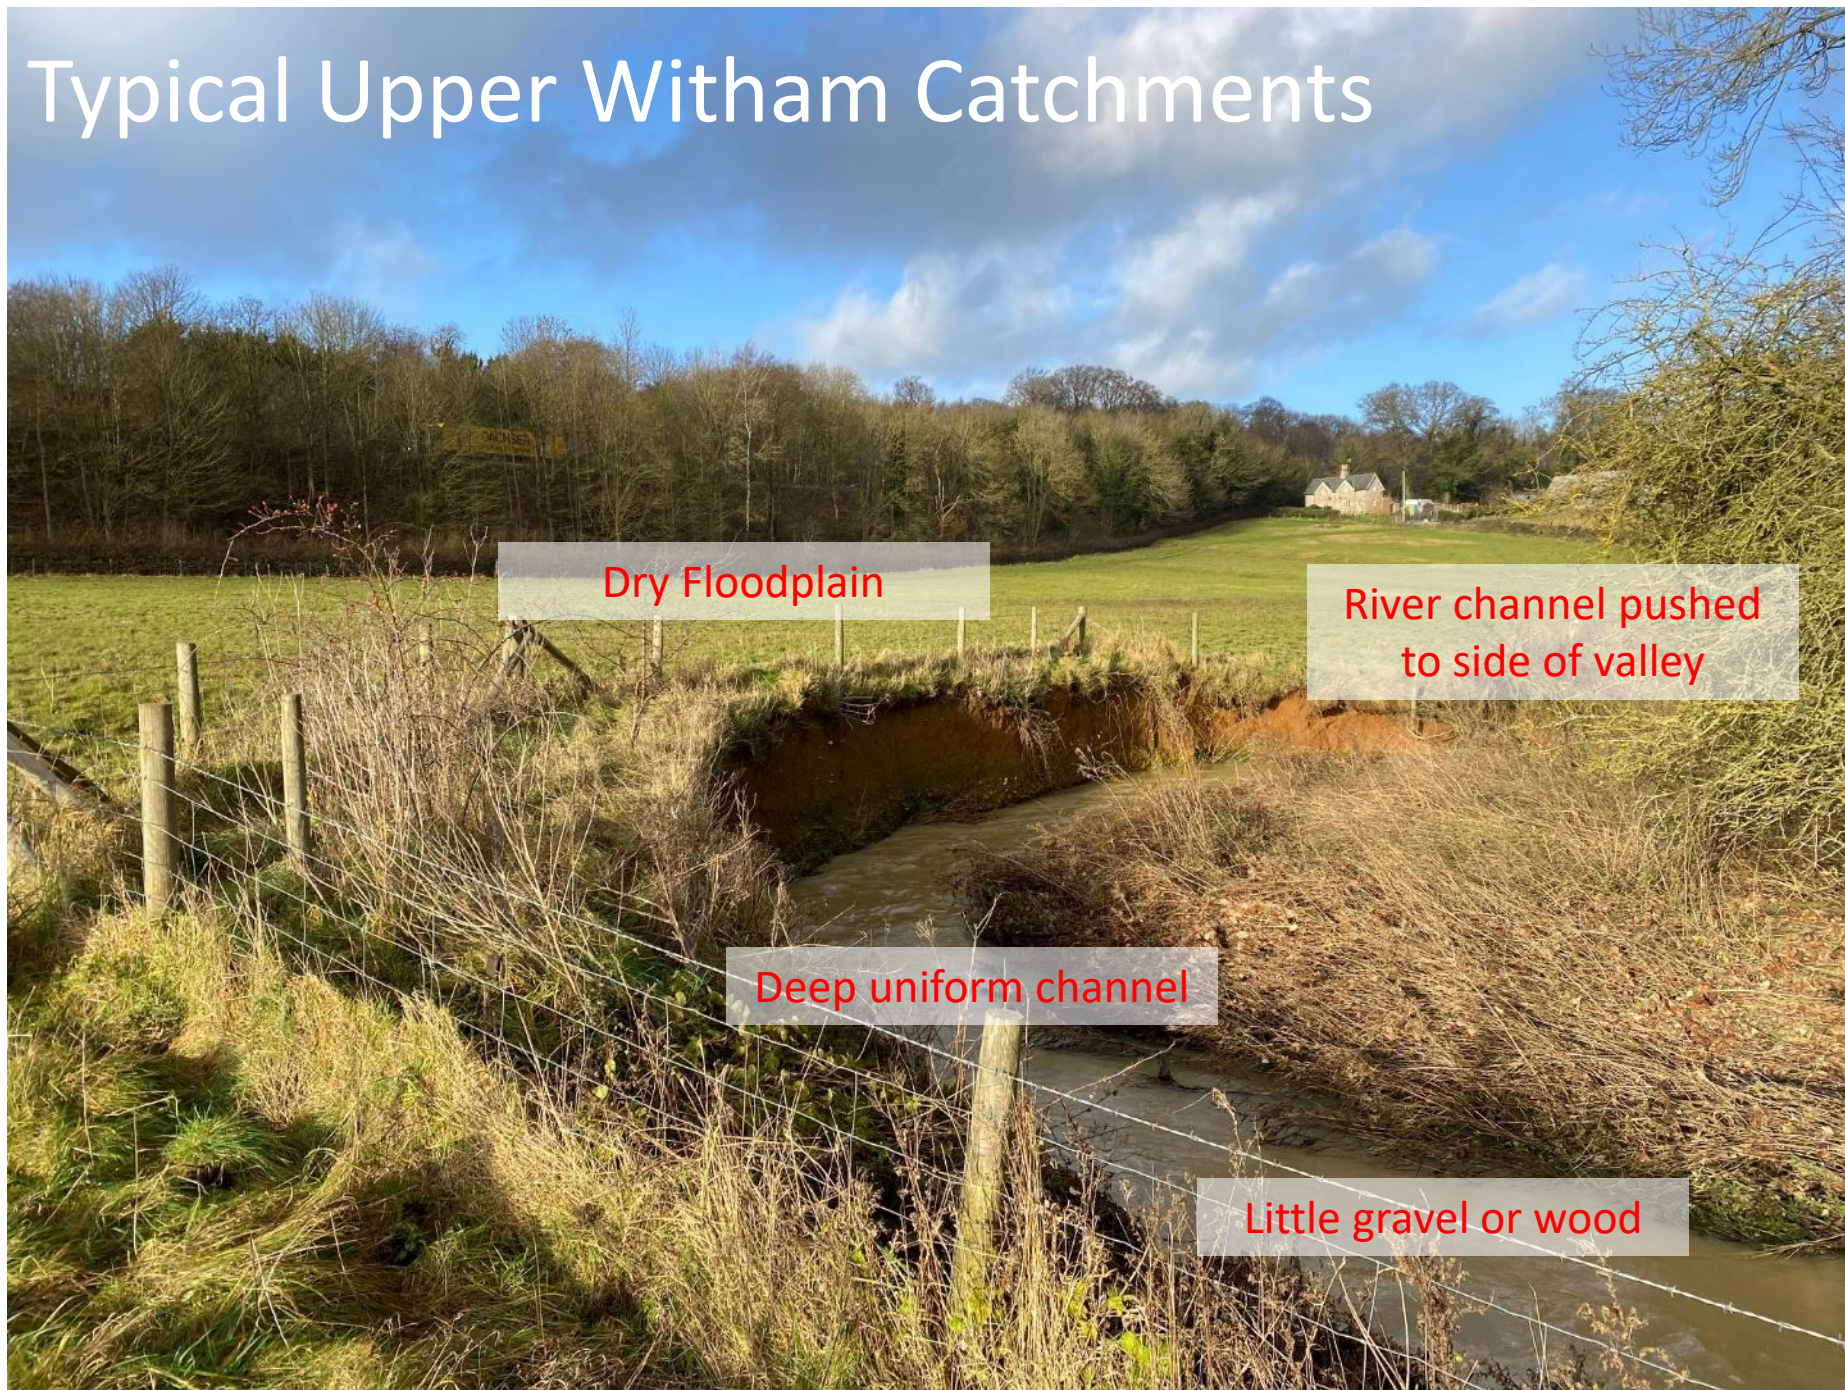
# Typical Upper Witham Catchments

Dry Floodplain

River channel pushed  
to side of valley

Deep uniform channel

Little gravel or wood

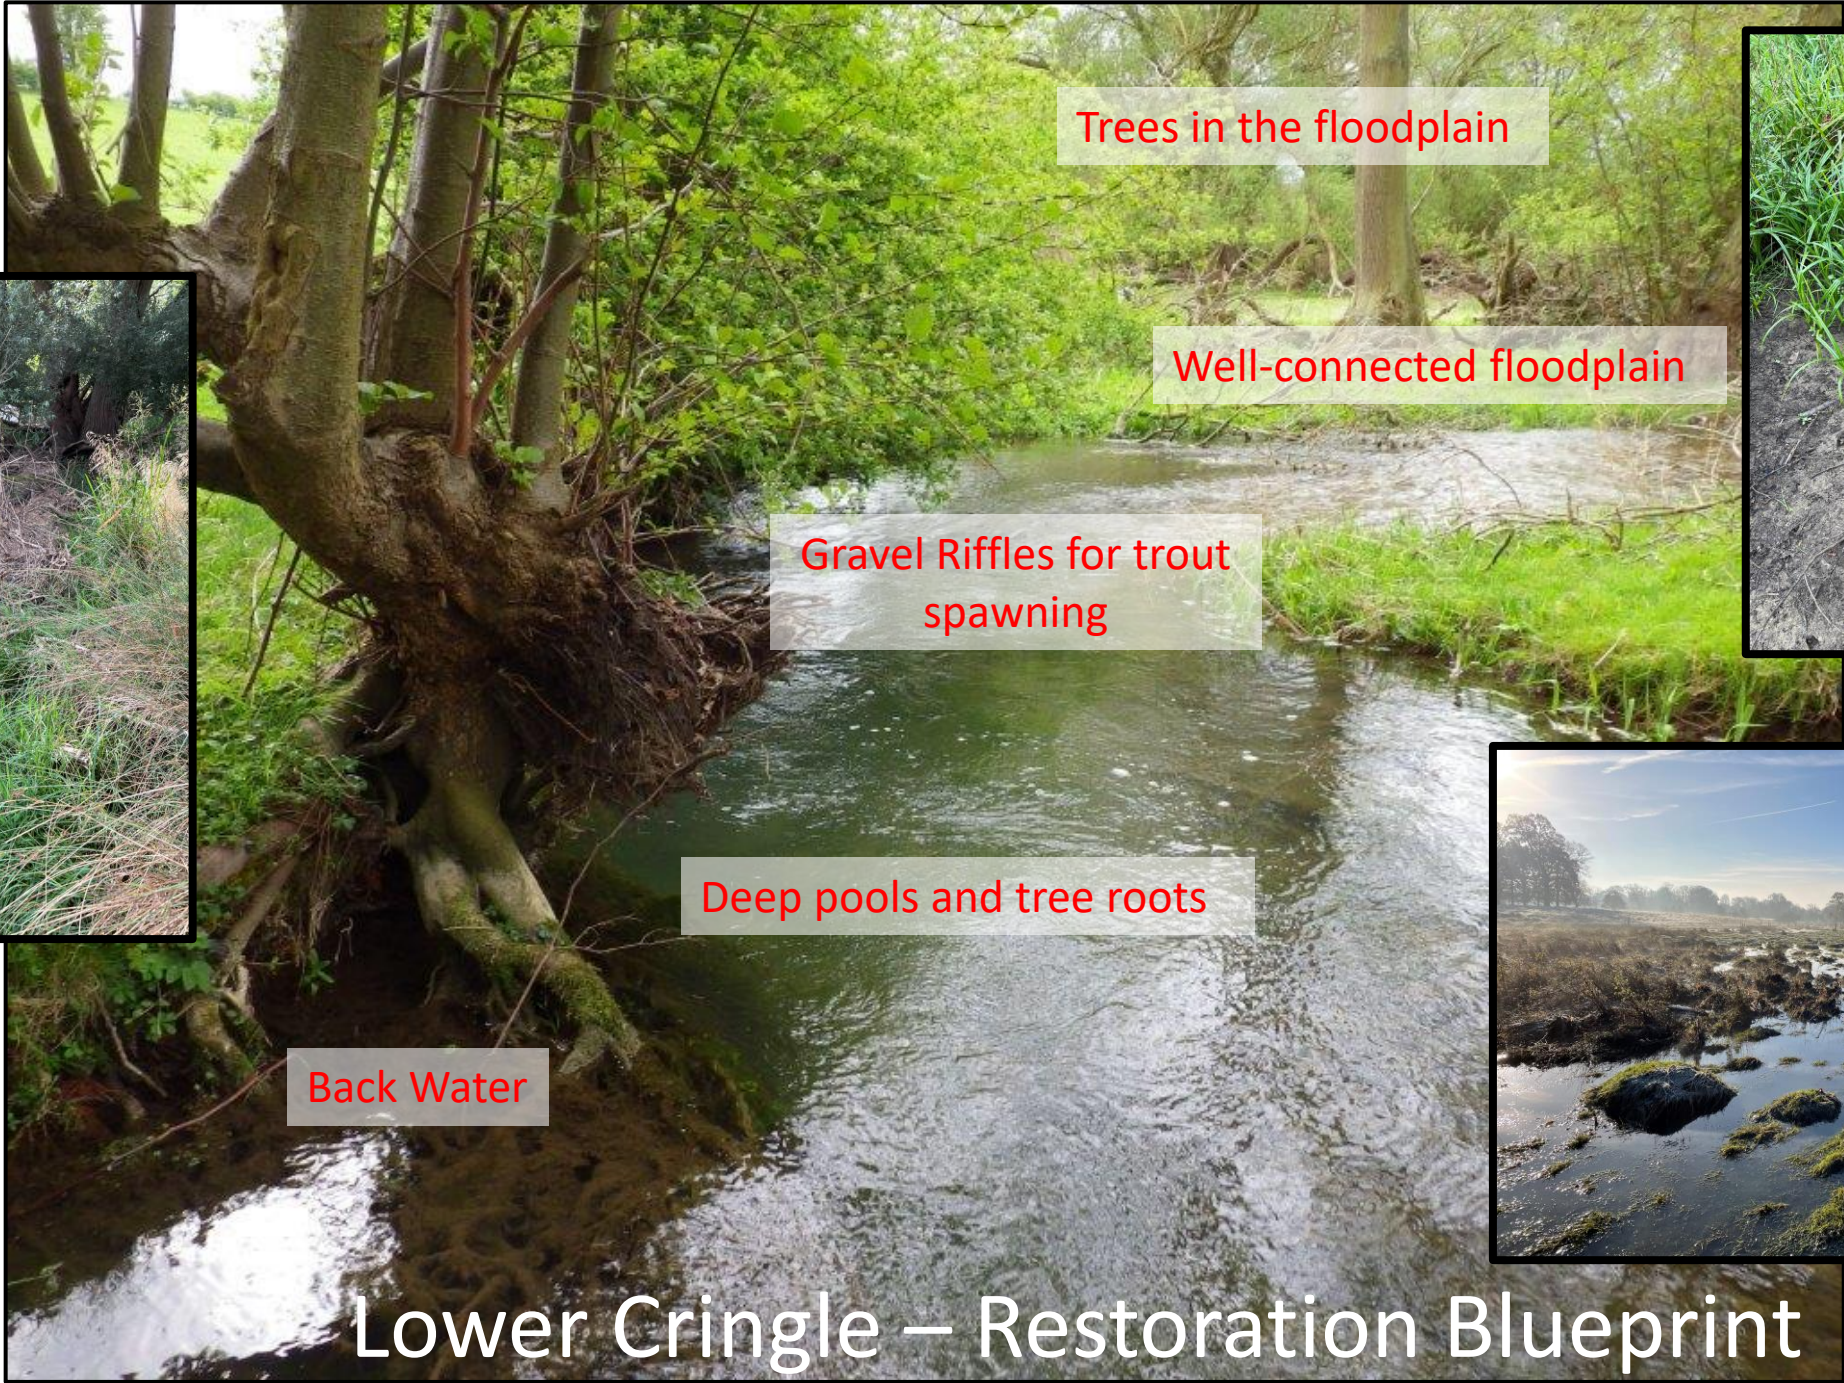
Trees in the floodplain

Well-connected floodplain

Gravel Riffles for trout spawning

Deep pools and tree roots

Back Water

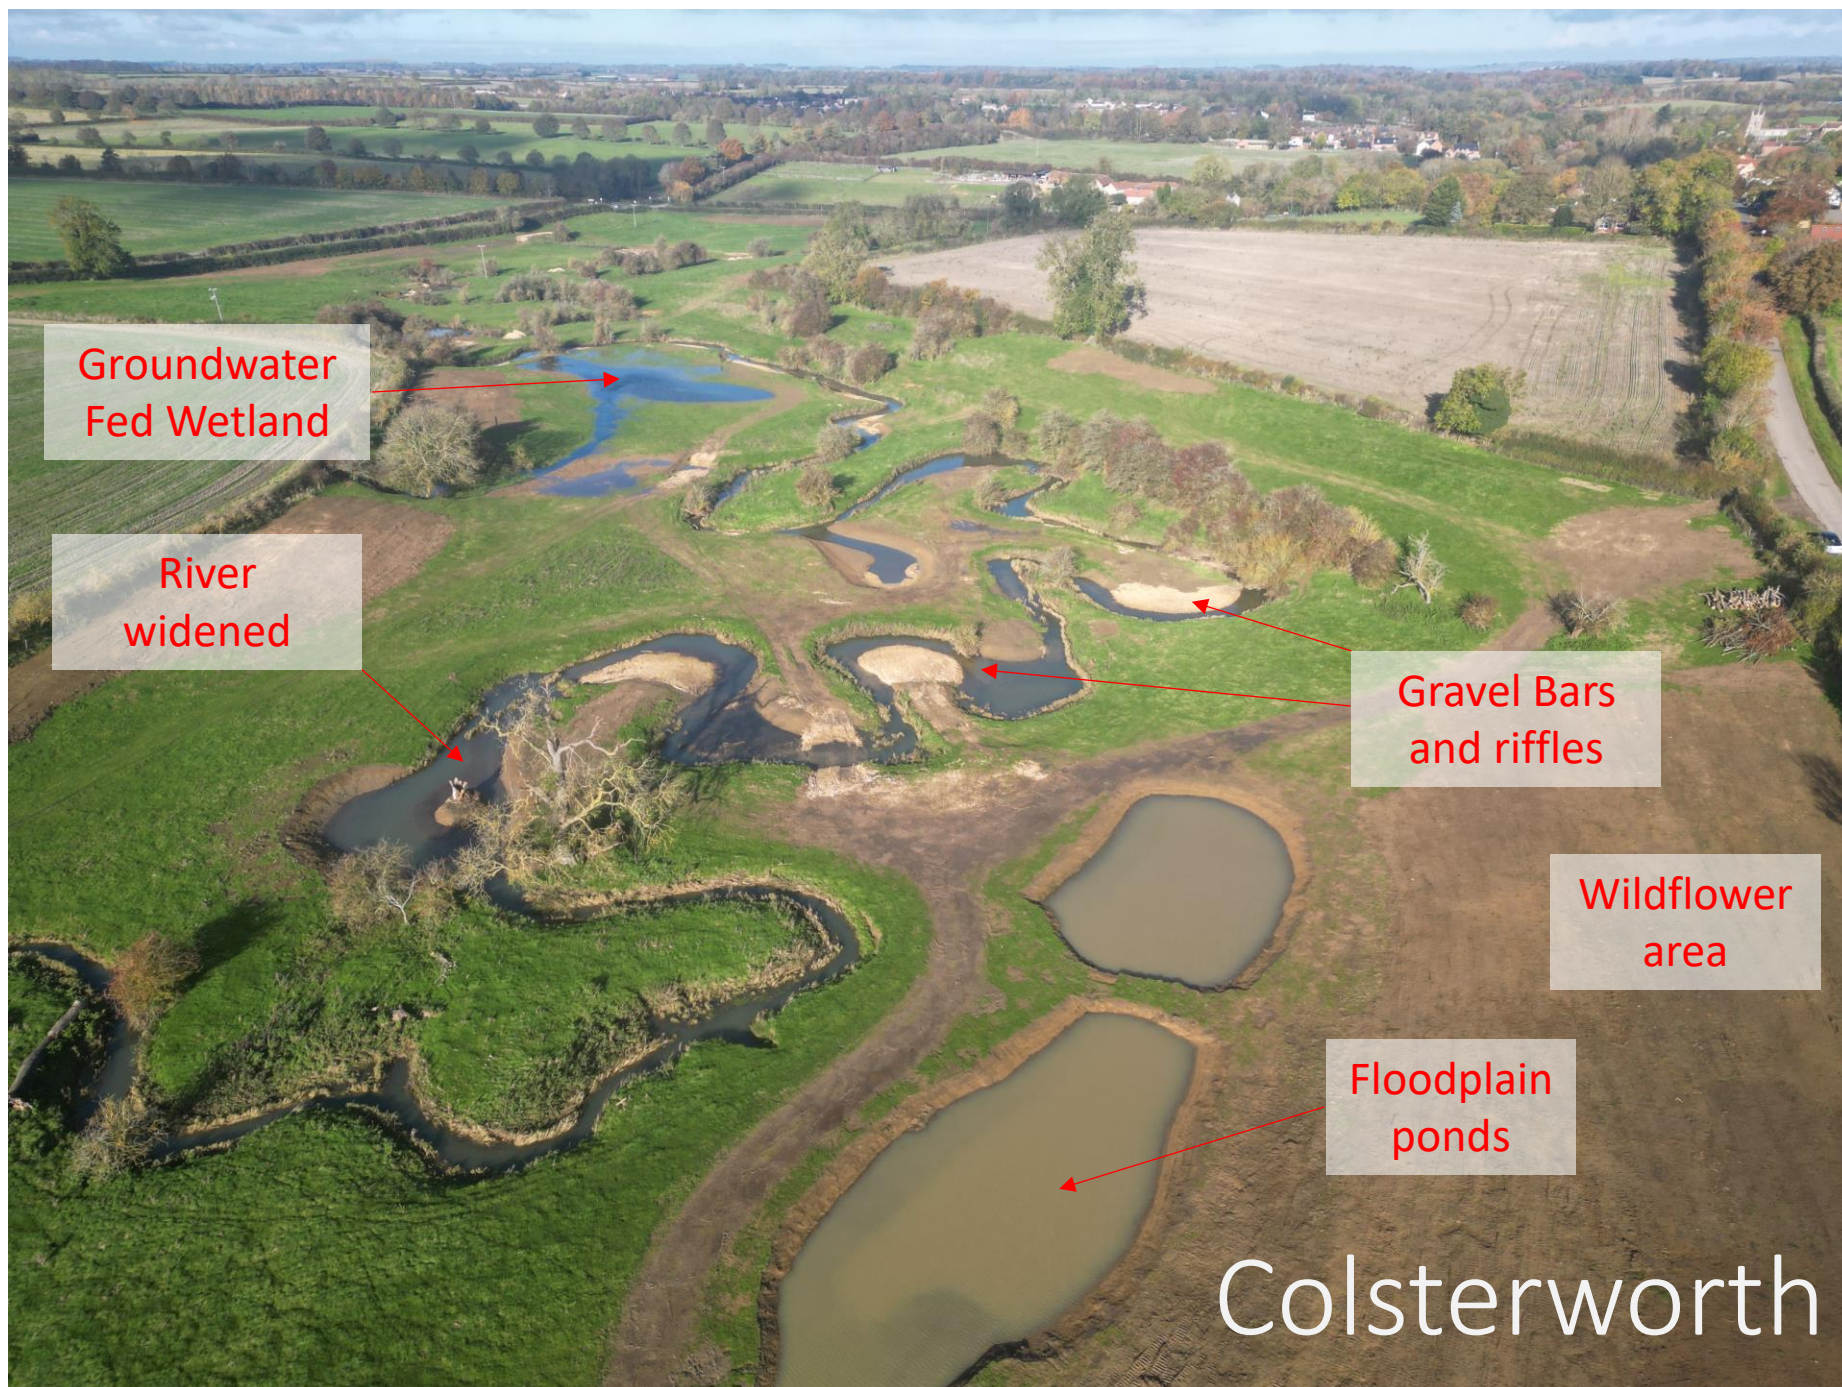
Colsterworth

Groundwater  
Fed Wetland

River  
widened

Gravel Bars  
and riffles

Wildflower  
area

Floodplain  
ponds

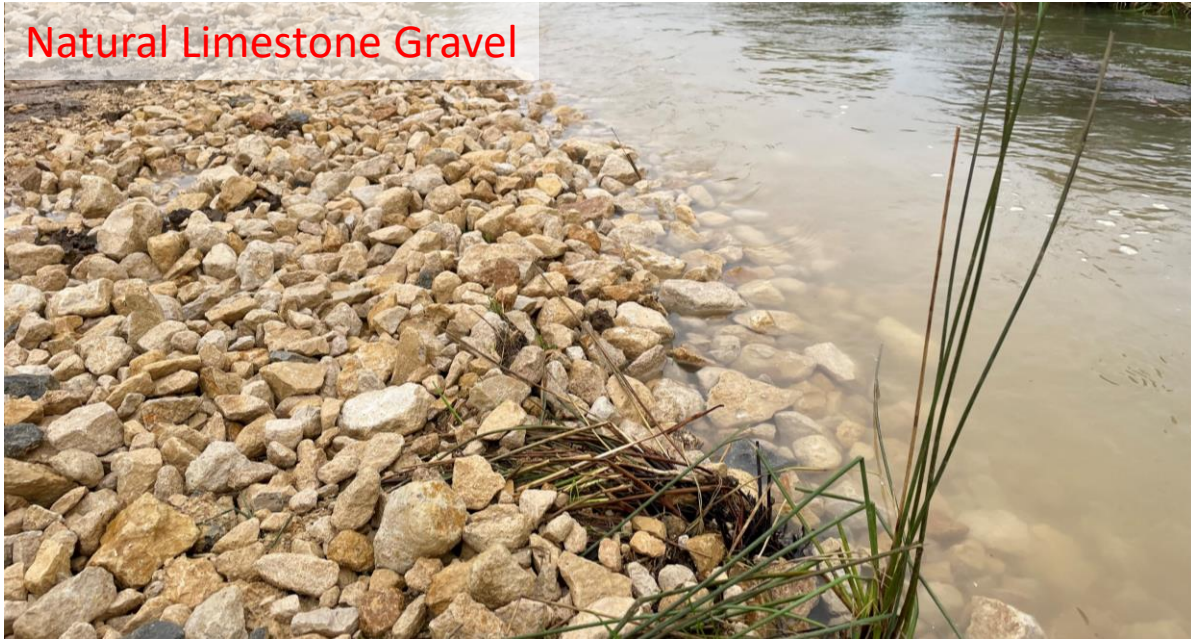
Natural Limestone Gravel

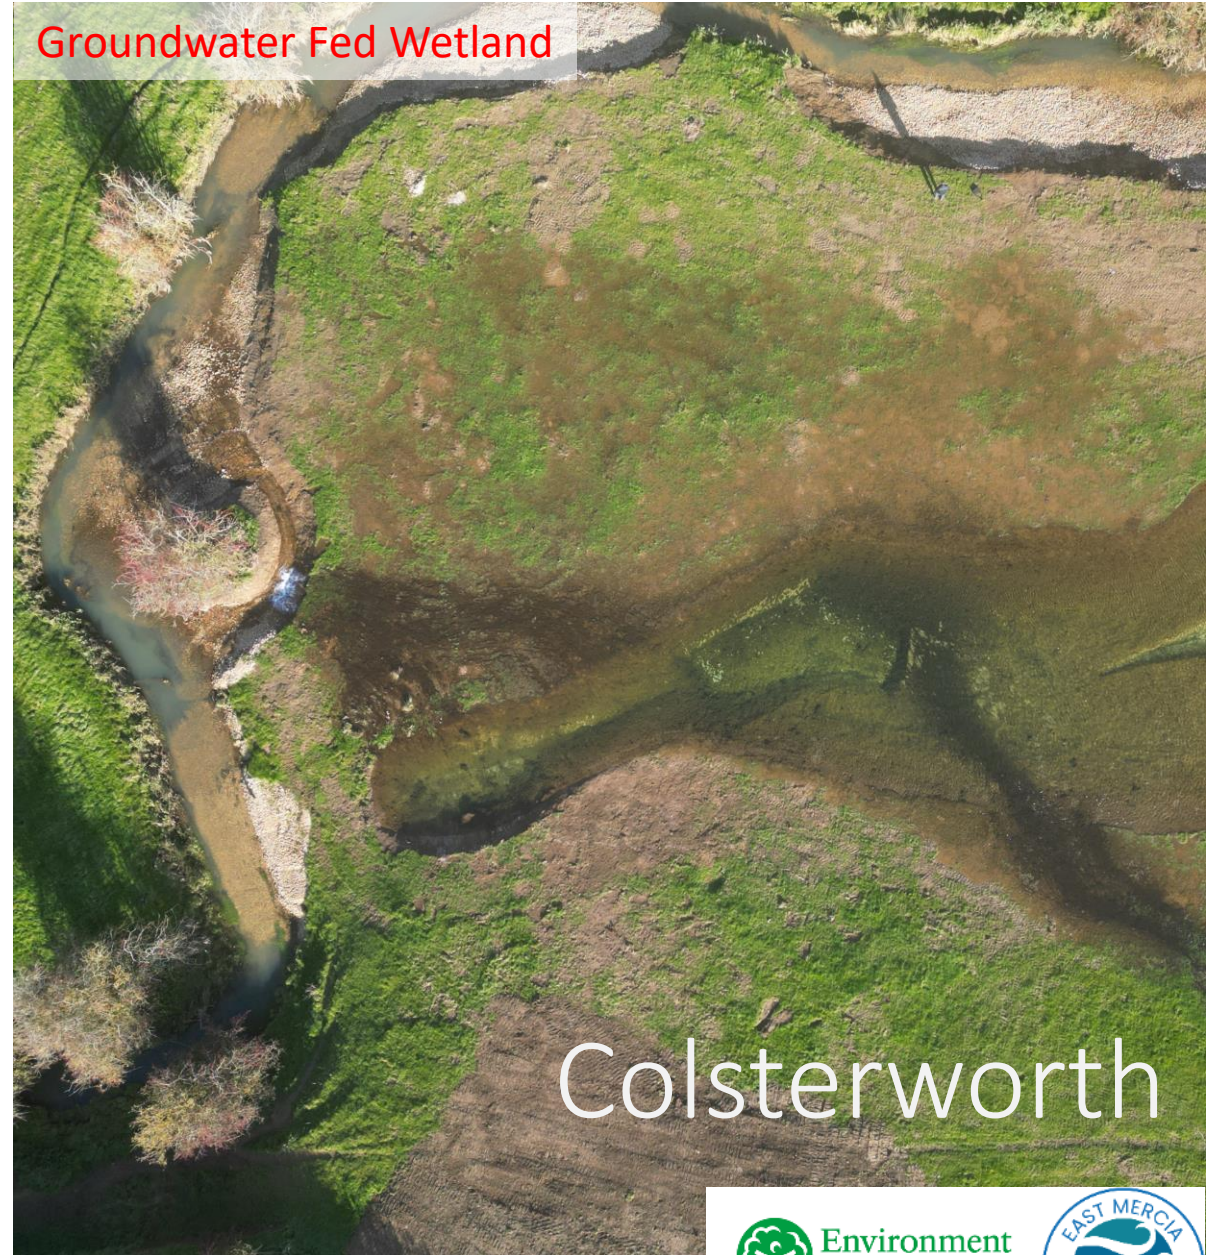
Groundwater Fed Wetland

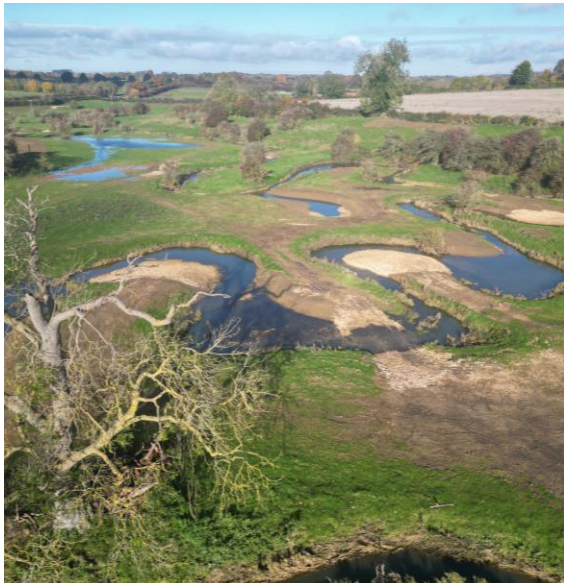
In-set Floodplain

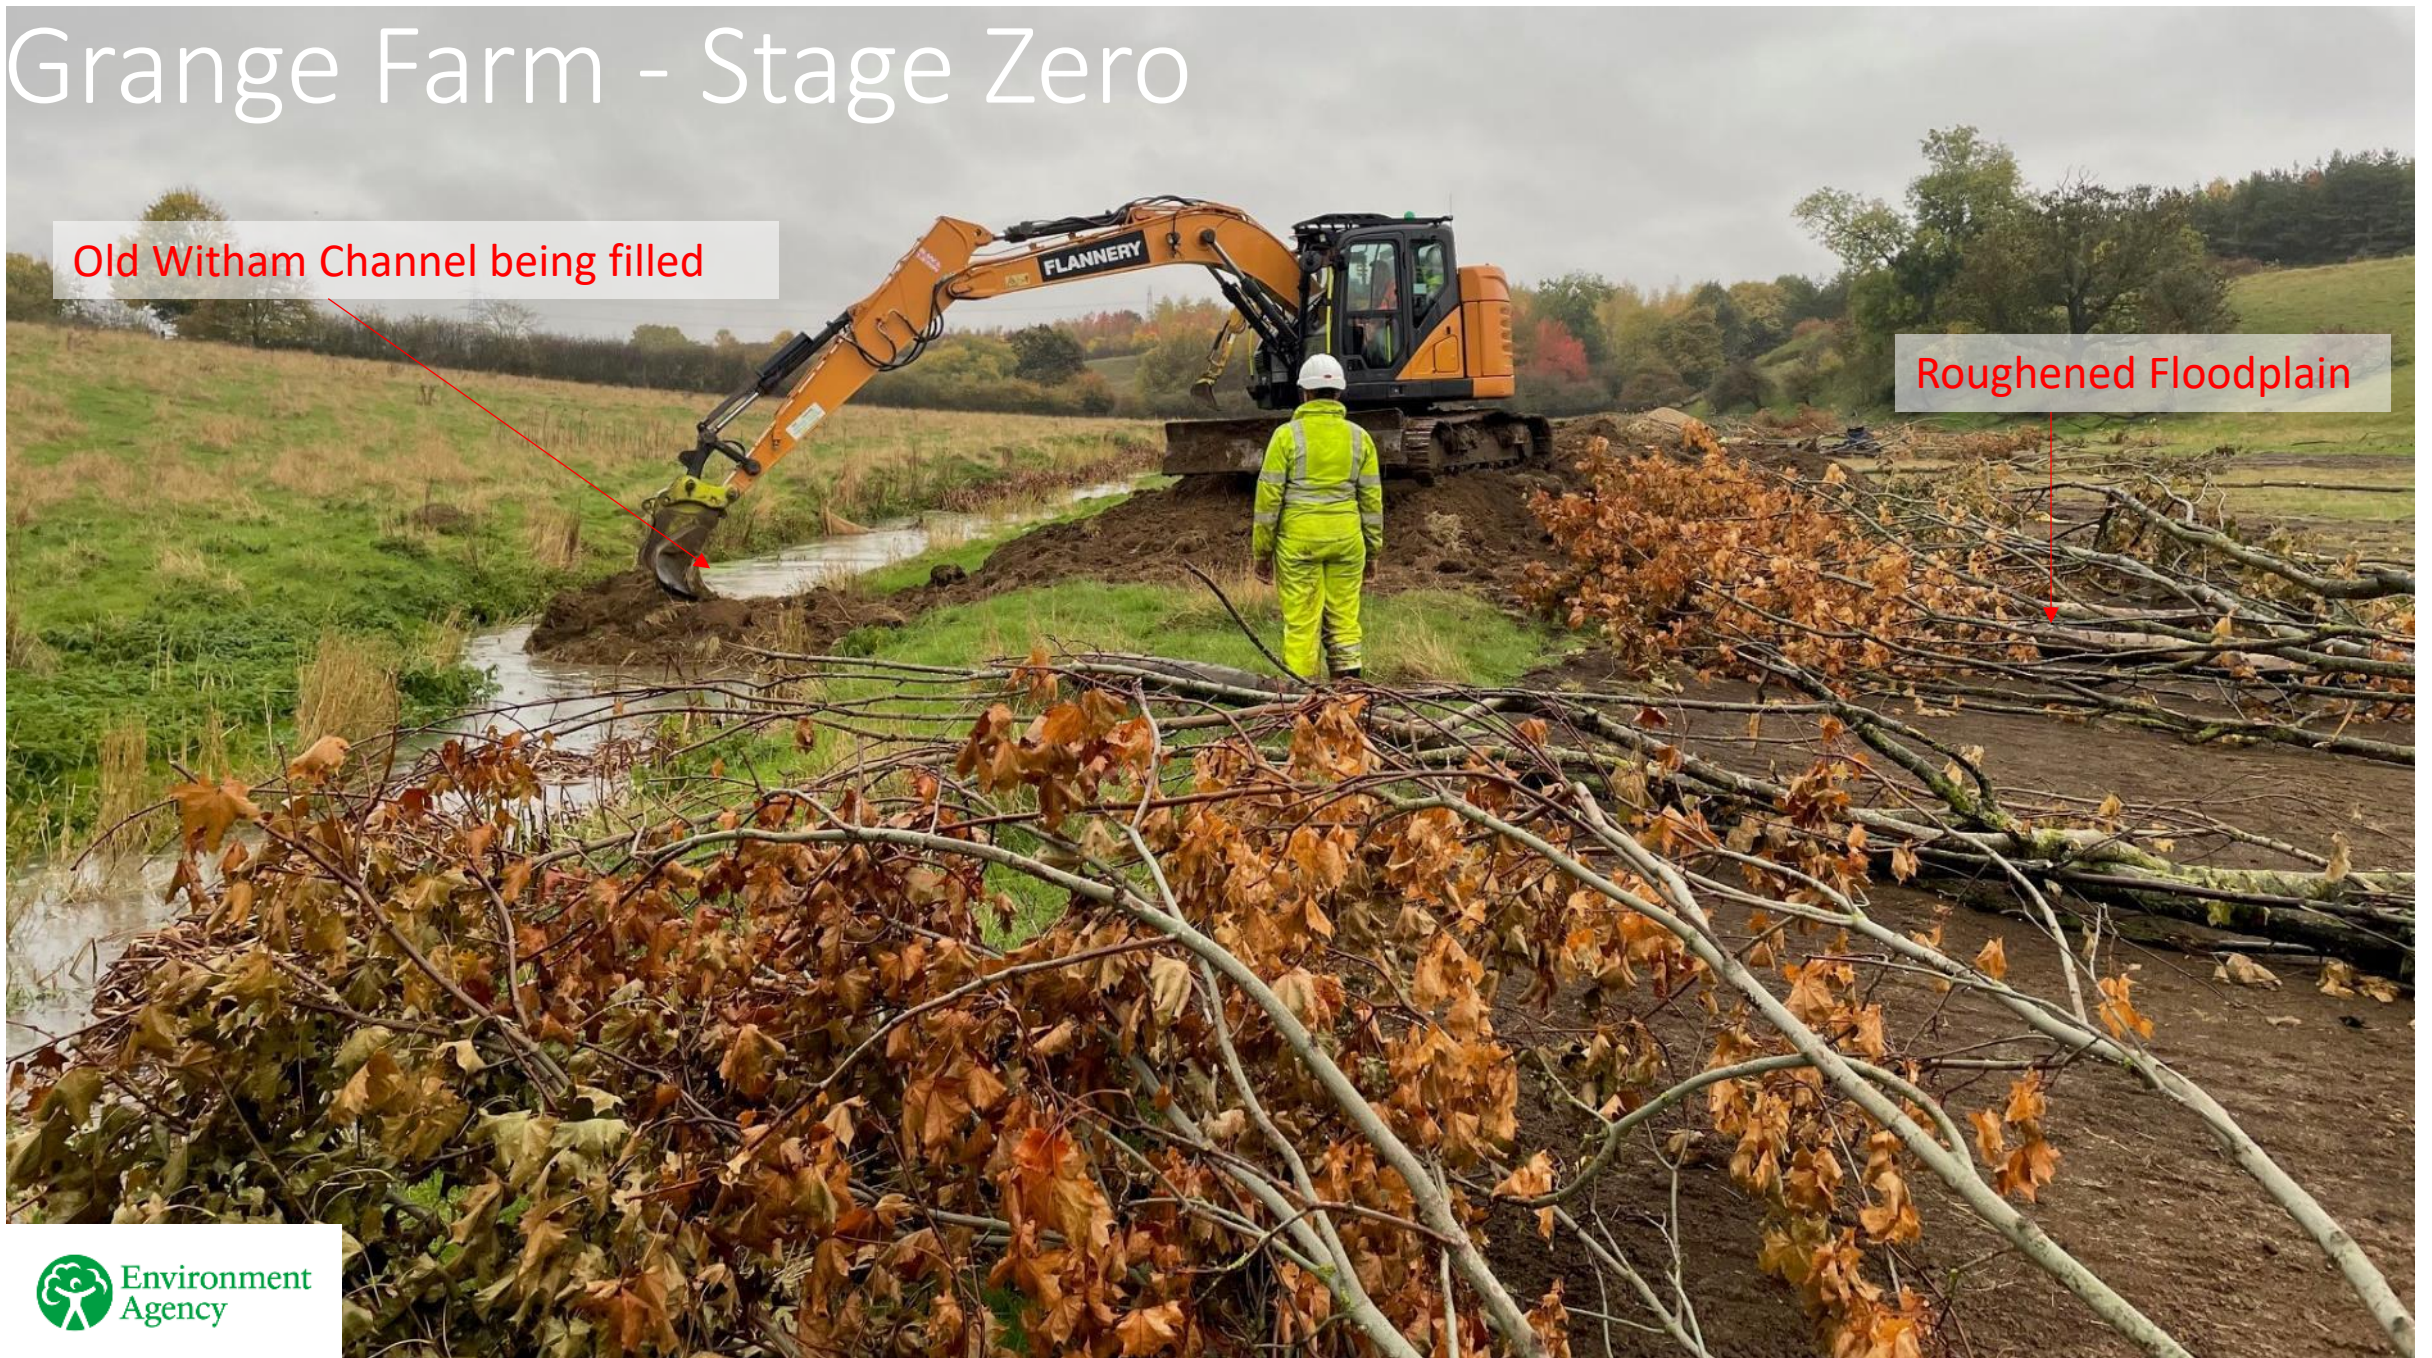
# Grange Farm - Stage Zero

Old Witham Channel being filled

Roughened Floodplain

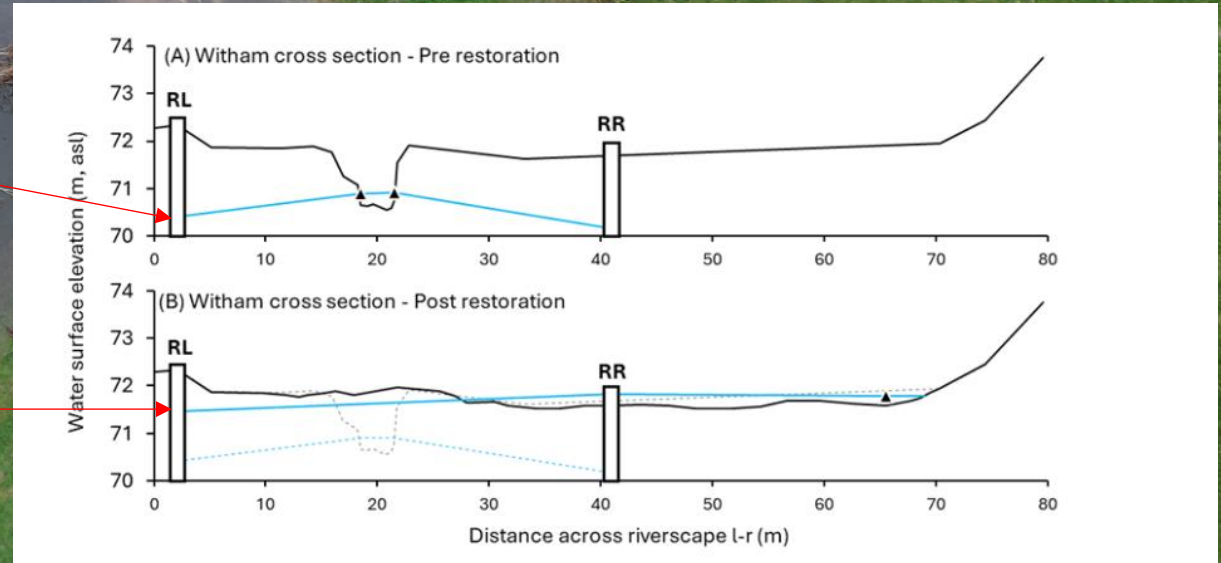
# Grange Farm - Stage Zero

River Witham Pre Project

Downstream end of project

Pre-restoration Ground Water Levels

Post-restoration Ground Water Levels

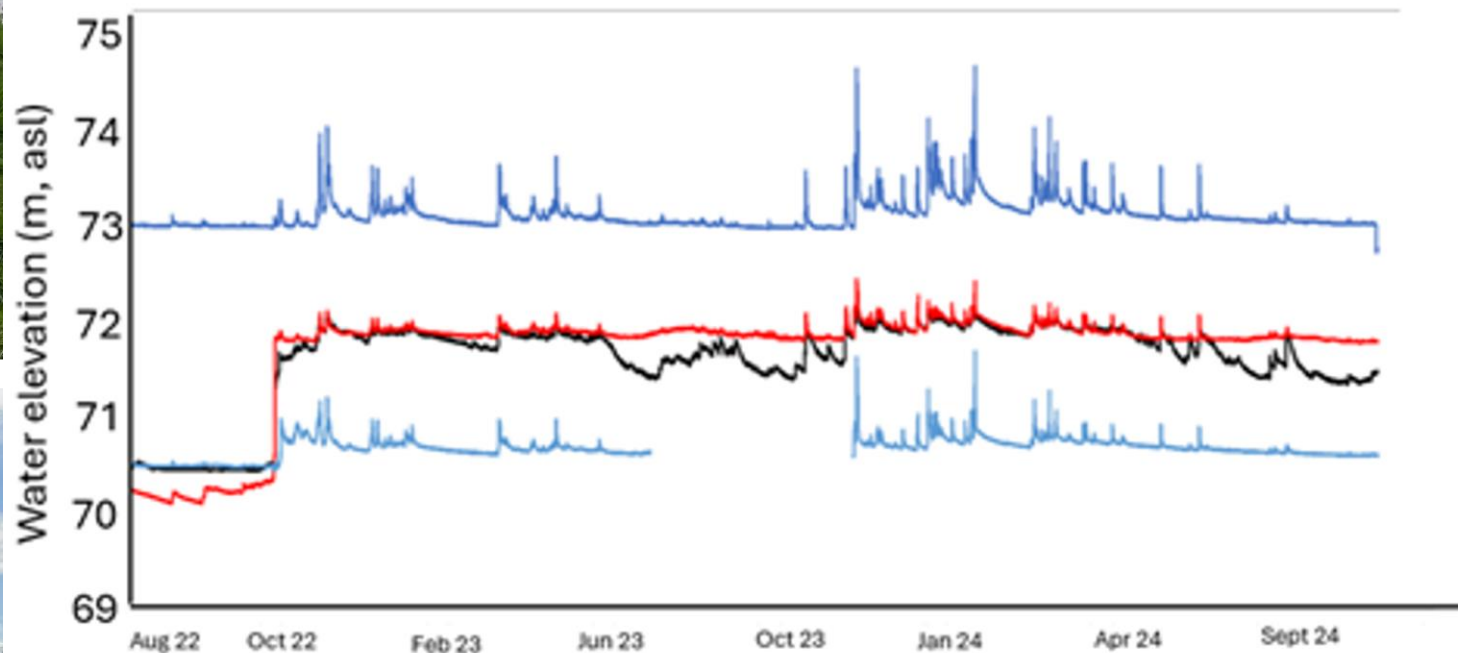
# Hydrological Changes

- Rapid rise in water level across site
- Water table held at floodplain surface for subsequent 2 years
- Evidence of attenuation of high flows and buffering of low flows
- Evidence that impacts propagate downstream

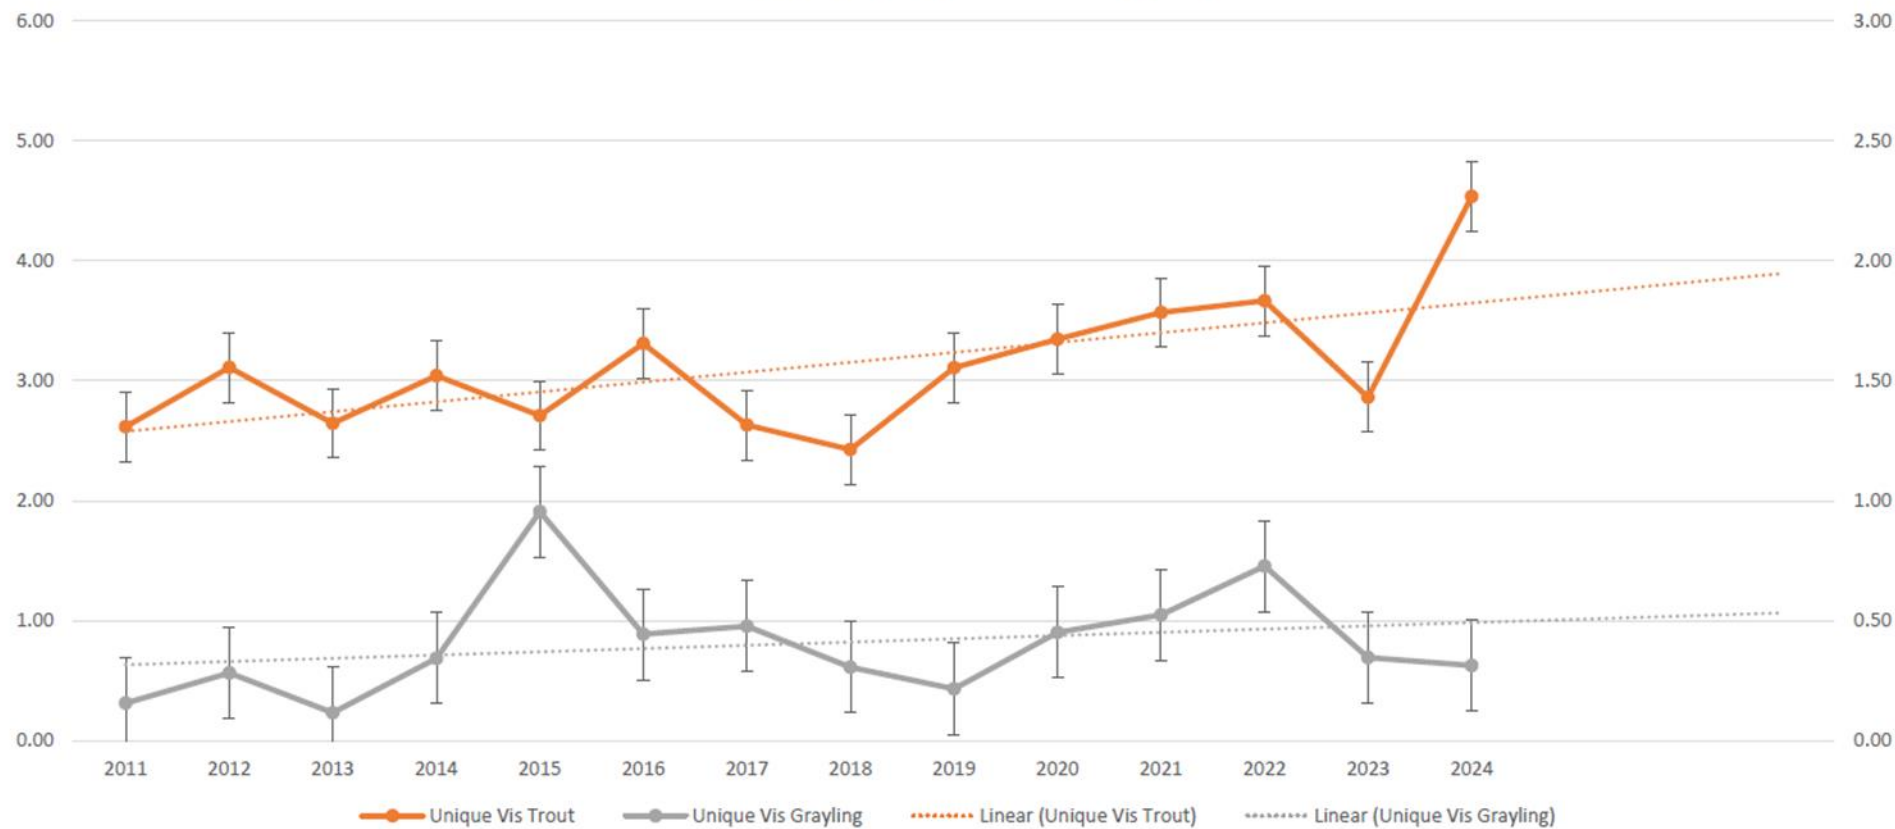
# TROUT AND GRAYLING TRENDS - RECENT

Averages by 'Unique Visits' - Since 2011
